RESERVE FUND STUDY

FOREST CROWNE CLOSE STRATA CORPORATION NES2947 300 & 400 BLOCK FOREST CROWNE CLOSE KIMBERLEY, BRITISH COLUMBIA

JUNE 2020

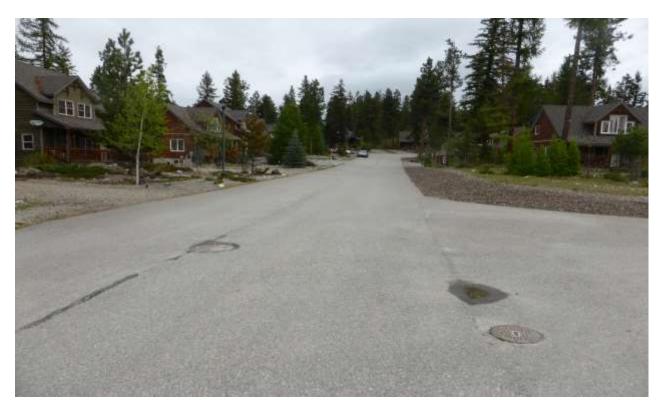
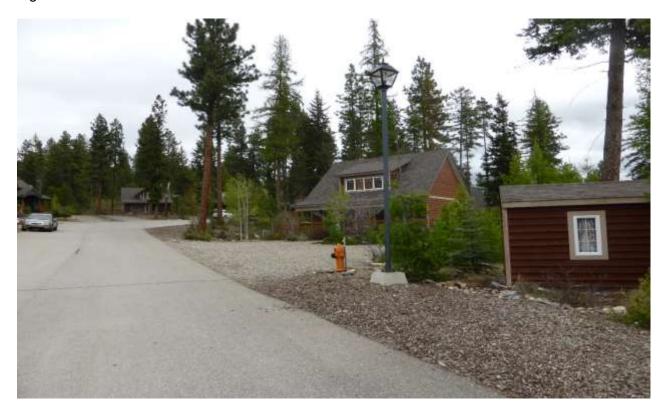
Reserve Compor	nent: (1) Site Improvements – Site Services			
Physical Description	This component is a contingency for replacement of underground water, sewer piping and valves providing service to the complex. It also includes the two fire hydrants. This is a contingency for any non-major underground repairs. It would also include any minor signage throughout the property. See Figure 1-1 & 1-2.			
Financial Analysis	There have been no reserve expenditures on this component in the last 5 years.			
Potential Deterioration	Water, sewer and storm sewer are brought to the property line of the Strata by the service provider and it is the Strata responsibility for any of these services within the common property up to the boundary of the home owner property. Piping can develop leaks and require digging up and repair. The sewer system may have a backup that requires a major cleanout. Repairs to water lines are the Strata responsibility up to an including the individual owner water valve as well as any underground utility that is serving multiple sites. A major failure of underground piping cannot be predicted and if it were to occur it would need to be handled by way of a special assessment.

Condition Analysis	Most site services are not visible. Where equipment appeared in good condition.	Most site services are not visible. Where viewing was possible equipment appeared in good condition.		
Life Cycle	Date of Acquisition	2007		
Analysis	Normal Life Span	20 Years		
	Effective Age	13 Years		
	Remaining Life Span	7 Years		
Unit Quantity	Unit Quantity	Allowance		
And Cost Estimates	Unit Cost Estimate	\$15,000		
	Current Repair or Replacement Cost Estimate	\$15,000		
	Estimated Year of Major Repair or Replaceme	nt 2024/29/34		
Deficiency Analysis	See comments above. Timing of future costs for this component is at best an estimate with actual expenditures to be expected to happen both before and after dates indicated. The above amount is simply a contingency to ensure funds are available but does not include any unforeseen or unpredictable major failures.

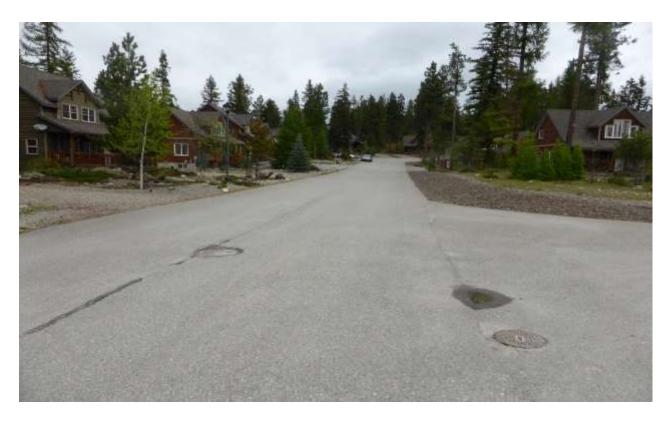
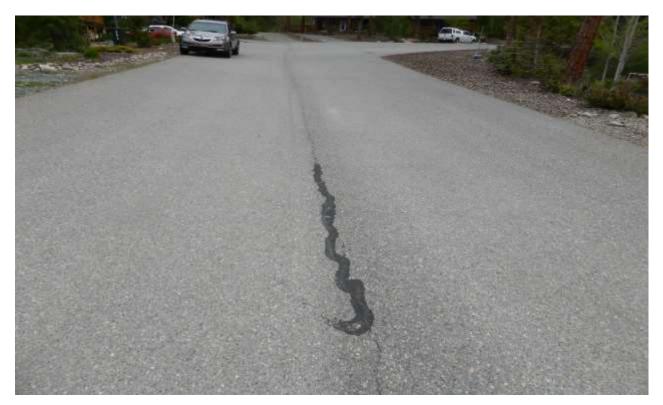
Reserve Component: (2) Site Improvements – Asphalt Paving				
Physical Description	This component includes resurfacing the asphalt paving that is run throughout the Strata common roadway system. See Figure 2-1 & 2-2.			
Financial Analysis	There has been \$1,788 in reserve expenditures in 2018 and 2019 for crack sealing.			
Potential Deterioration	If the ground settles from poor compaction the asphalt will settle and crack. Cracking allows moisture to get in and if cracks are not sealed it can lead to bigger cracks and major repairs. Surface drainage issues can cause undercutting of the asphalt and can lead to further settling and cracking. If services are run under the asphalt on original construction and not properly compacted it can lead to settling and major repairs to the asphalt.			
Condition Analysis	The asphalt appeared in average condition with no major issues identified. Water drainage appears to run down the middle of the roadways to storm drains located in several locations throughout the complex. There are no ditches so the roadways are the normal water course which can produce some undercutting over time.

Life Cycle	Date of Acquisition	2007		
Analysis	Normal Life Span	25 Years		
	Effective Age	13 Years		
	Remaining Life Span	12 Years		
Unit Quantity	Unit Quantity	30,000 sq. ft.		
And Cost Estimates	Unit Cost Estimate	\$2.5 per sq. ft.		
	Current Repair or Replacement Cost Estimate	\$75,000		
	Estimated Year of Major Repair or Replacement	2032		
Deficiency Analysis	See comments above. Minor funds have been included for sealing cracks and minor repairs in 2022 and 2027.

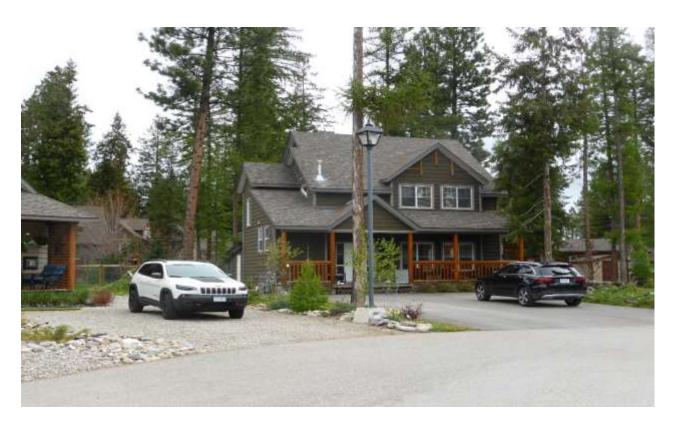
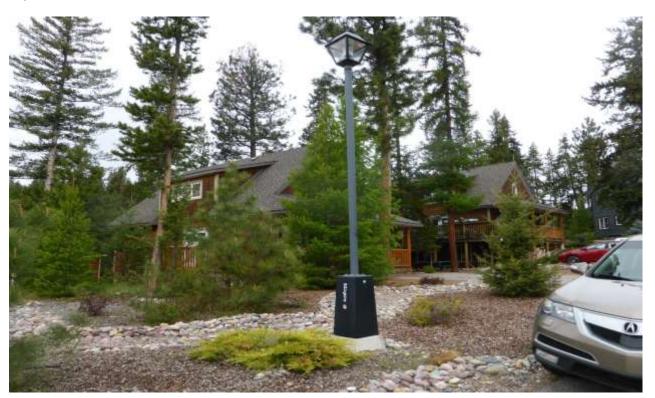
Reserve Component: (3) Site Improvements – Electrical & Lighting				
Physical Description	This component includes repairs and replacement of the 8 streetlights as well as any other common electrical issues throughout the Strata. See Figure 3-1 & 3-2.			
Financial Analysis	There have been no reserve expenditures on this component in the last 5 years.			
Potential Deterioration	Exterior pedestal lighting should be relatively maintenance free. Pedestals may require painting and supports may require repairs. Light covers may need replacing. Any common electrical including underground may require repairs over time. Lighting technology is continually improving and upgrades to it may also occur.			
Condition Analysis	The lighting and electrical appeared in good condition with no issues identified. A retrofit to LED is being planned for the upcoming year.			
Life Cycle	Date of Acquisition	2007		
Analysis	Normal Life Span	25 Years

Effective Age	13 Years		
	Remaining Life Span	12 Years		
Unit Quantity	Unit Quantity	Allowance		
And Cost Estimates	Unit Cost Estimate	\$15,000		
	Current Repair or Replacement Cost Estimate	\$15,000		
	Estimated Year of Major Repair or Replacement	2021/27/31/33		
Deficiency Analysis	No issues were identified with this component. Funds have been included in the upcoming year for the LED upgrade. Additional funds are included every 5 years starting in 2027 for any premature failures.

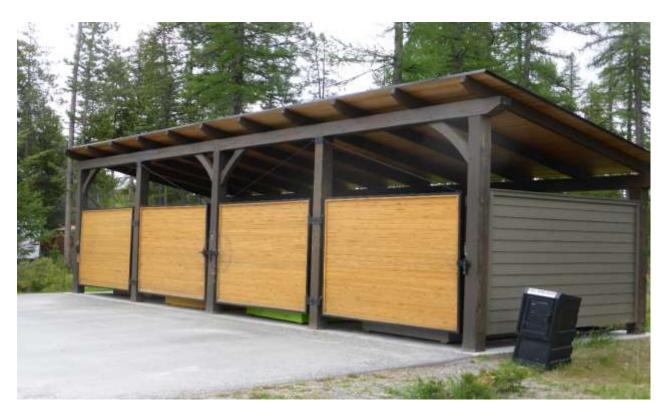
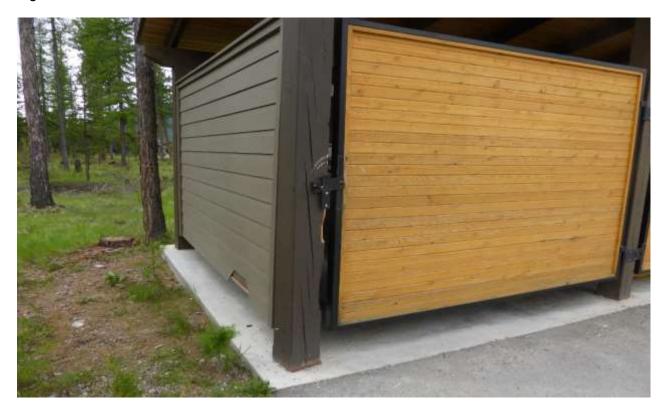
Reserve Component: (4) Site Improvements – Garbage Enclosure				
Physical Description	enclosure which is jointly owned between three	This component includes repair or replacement of the garbage enclosure which is jointly owned between three adjoining Strata properties with all costs split proportionately. Figure 4-1 & 4-2.		
Financial Analysis	There have been no reserve expenditures on this last 5 years.	There have been no reserve expenditures on this component in the last 5 years.		
Potential Deterioration		Gates may need repair. The exterior of the enclosure will need ongoing maintenance. The concrete pad and asphalt ramp may need repair.		
Condition Analysis				
Life Cycle	Date of Acquisition	2010		
Analysis	Normal Life Span	30 Years		
	Effective Age	10 Years		
	Remaining Life Span	20 Years		
Unit Quantity	Unit Quantity	Allowance		
And Cost Estimates	Unit Cost Estimate	\$10,000 (33%)		
	Current Repair or Replacement Cost Estimate	\$10,000

Estimated Year of Major Repair or Replacement	2040		
Deficiency Analysis	See comments above. Minor funds have been included in 2030 for repairs that may be needed prior to replacement.

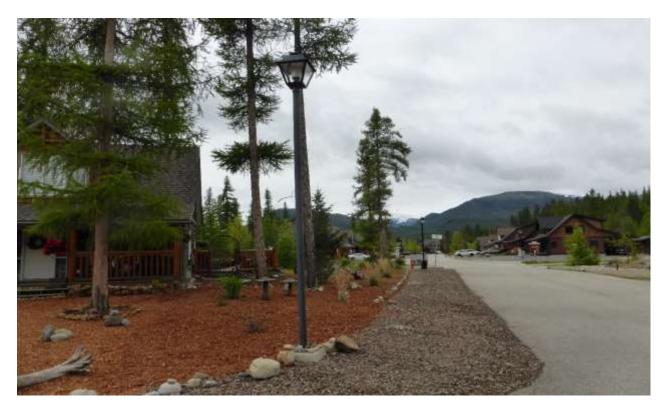
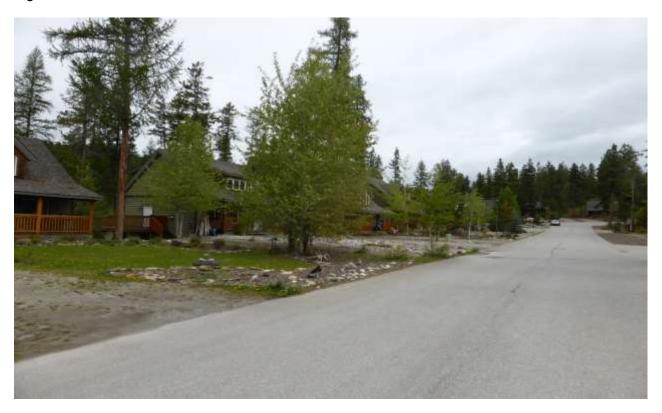
Reserve Component: (5) Site Improvements – Landscaping & Site Drainage			
Physical Description	This component includes non annual costs associated with maintaining any common landscaping and site drainage. See Figure 5-1 & 5-2.		
Financial Analysis	There have been no reserve expenditures on this component in the last 5 years.		
Potential Deterioration	Most owners have chosen to landscape right up to the roadway which includes the common property on each side of the paved roadway. Should common property need to be dug up and then repaired for any reason the Strata is only responsible for repairing it to a flat and level state as it was when originally provided to the homeowner. The homeowner would be responsible to make repairs to improvements that they have installed on the common property. There are no ditch lines along the road and the area is flat. Site drainage issues could also arise. The amounts included in this report are a contingency for any related expenditure.

Condition Analysis	90 percent of the lots have homes on them and are for the most part landscaped by the owners right up to the roadway. The few remaining open lots have rough grading and no landscaping.		
Life Cycle Analysis	Date of Acquisition	2007	
	Normal Life Span	20 Years	
	Effective Age	13 Years	
	Remaining Life Span	7 Years	
Unit Quantity And Cost Estimates	Unit Quantity	Allowance	
	Unit Cost Estimate	\$10,000	
	Current Repair or Replacement Cost Estimate	\$10,000	
	Estimated Year of Major Repair or Replacement	2022/27/32	
Deficiency Analysis	See comments above. This is a contingency and actual timing may vary. Funds have been included every 5 years starting in 2022.
